## City of Alexandria Storm Sewer Capacity Analysis (CASSCA)

### Backlick Run Condition Assessment

**PREPARED FOR:** City of Alexandria, CH2M Hill  
**PREPARED BY:** Michael Baker Jr., Inc.  
**DATE:** October 9, 2013 (Revised May 26, 2015)

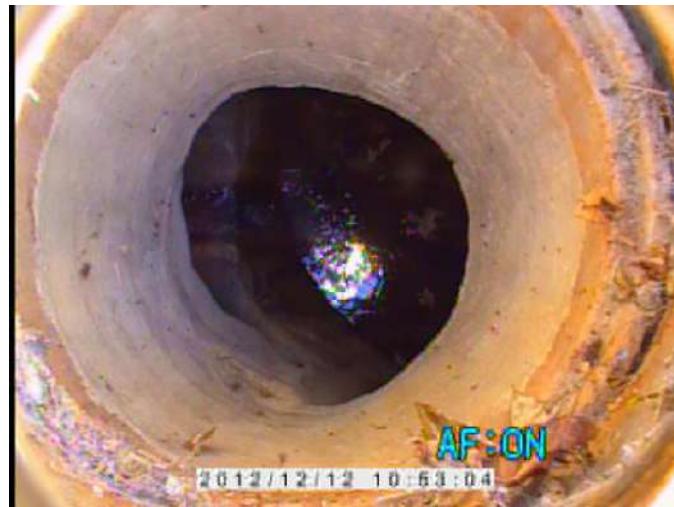
**Figure 4. Moderate Frame Base Seal Damage on Structure 001025SMH  
(Overall SCREAM Score = 59).**

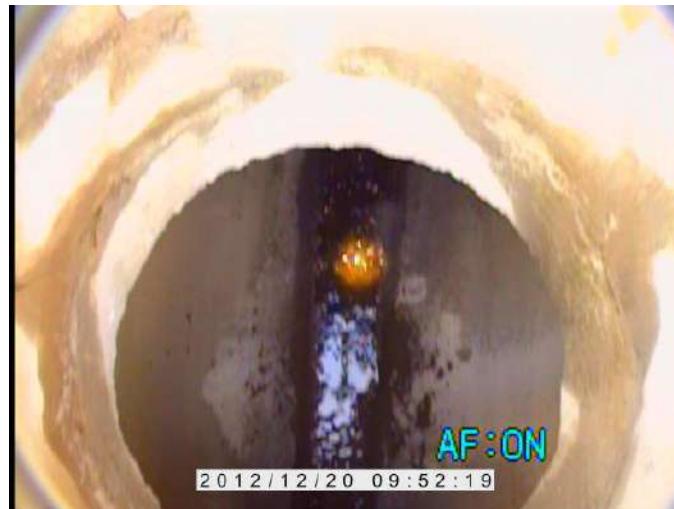
**Figure 5. Moderate Chimney Damage on Structure 001102SMH  
(Overall SCREAM Score = 62).**

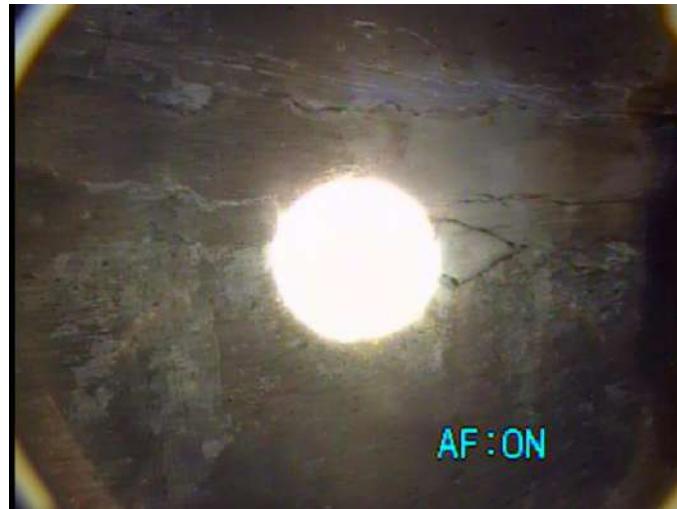
**Figure 6. Moderate Chamber Wall Damage on Structure 005073IN  
(Overall SCREAM Score = 42).**

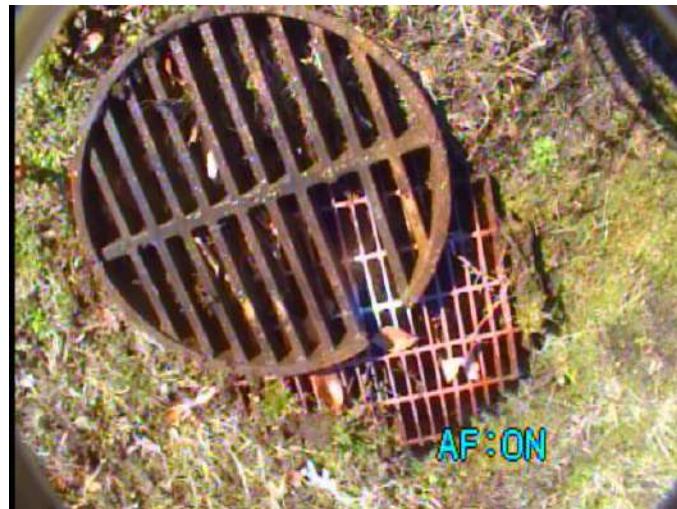
**Figure 7. Broken Inlet Grate at Structure 004339IN  
(Overall SCREAM Score = 98).**

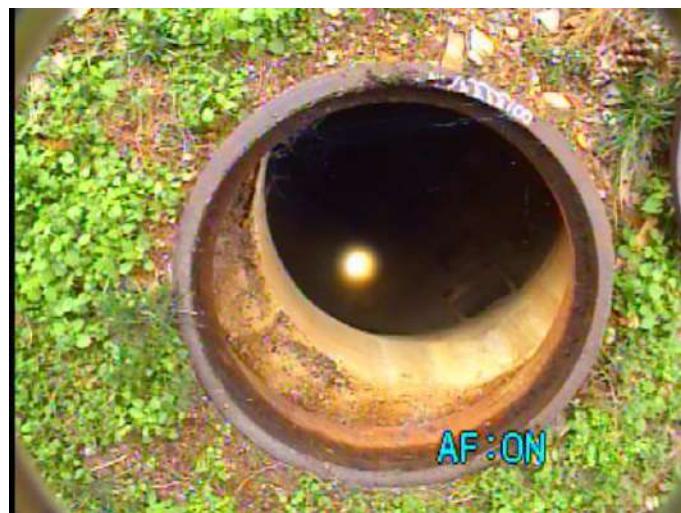
**Figure 8. Offset Frame in Structure 001333SMH  
(Overall SCREAM Score = 78).**

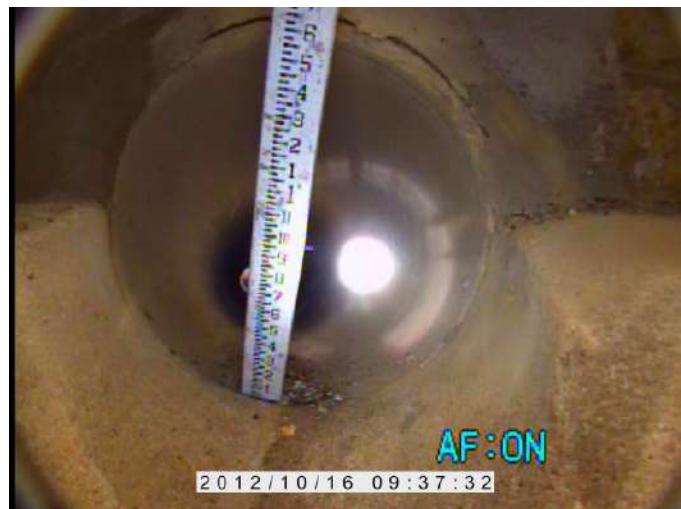
**Figure 9. Separated Pipe Connection in Structure 002155IN  
(Overall SCREAM Score = 52).**

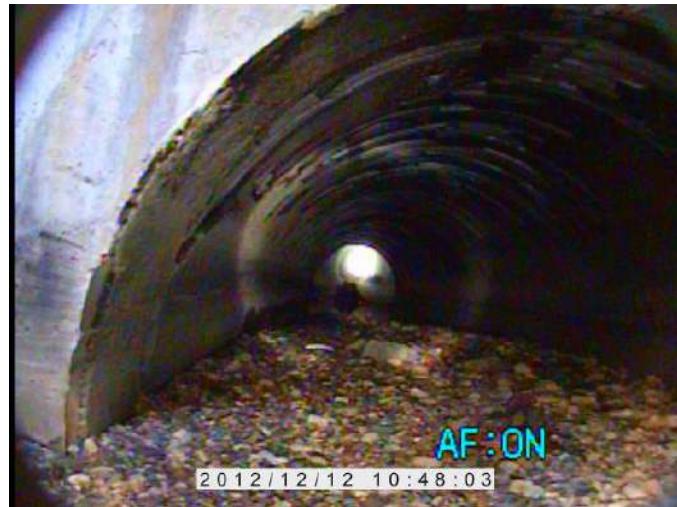
**Figure 10. Heavy Debris in Structure 001024SMH  
(Overall SCREAM Score = 64).**

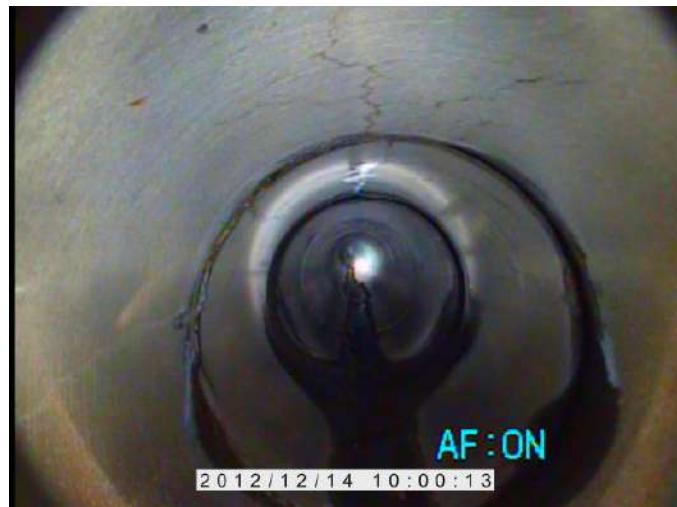
Several cracks were observed in one pipe segment as shown in Figure 13. This segment has a SCREAM score of 9 (Few). Root intrusions were observed in one pipe segment as shown in Figure 14. This segment has a SCREAM score of 50 (Moderate). Limited infiltration was observed in the segments with SCREAM scores less than 10. Figure 15 is an example of the level of infiltration in these storm pipes.

**Figure 13. Cracks in 24-in Storm Pipe between Structures 003601SMH and 001166SMH  
(Overall SCREAM Score = 9).**

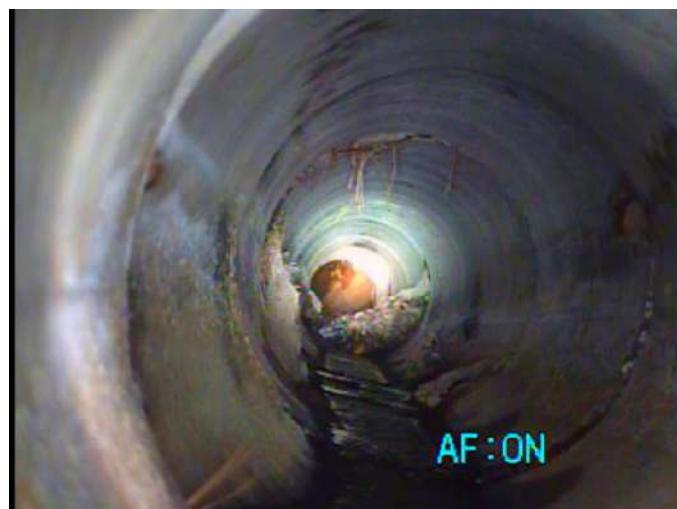
**Figure 14. Root Intrusion in 15-in Storm Pipe between Structures 004141IN and 004140IN  
(Overall SCREAM Score = 50).**

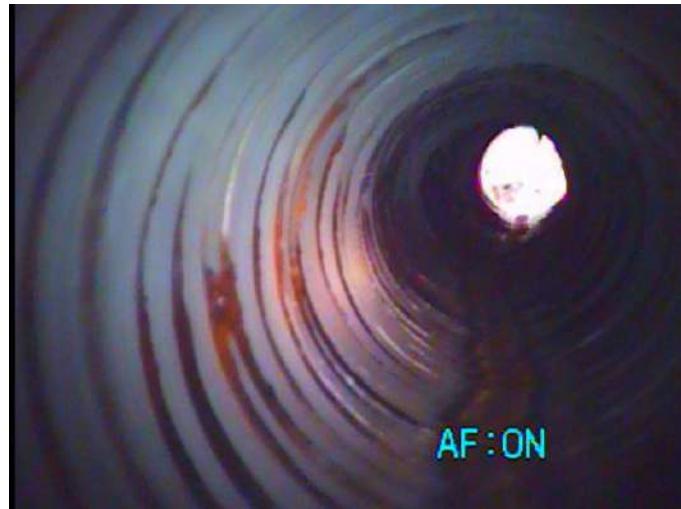
**Figure 15. Infiltration in 36-in Storm Pipe at Structure 000229CP  
(Overall SCREAM Score = 7).**
